THE MOORES PROJECT

Conservation of The Moores Complex of Buildings

Booklet Prepared by the
Architecture & Heritage Section
City of Fremantle

April 1995

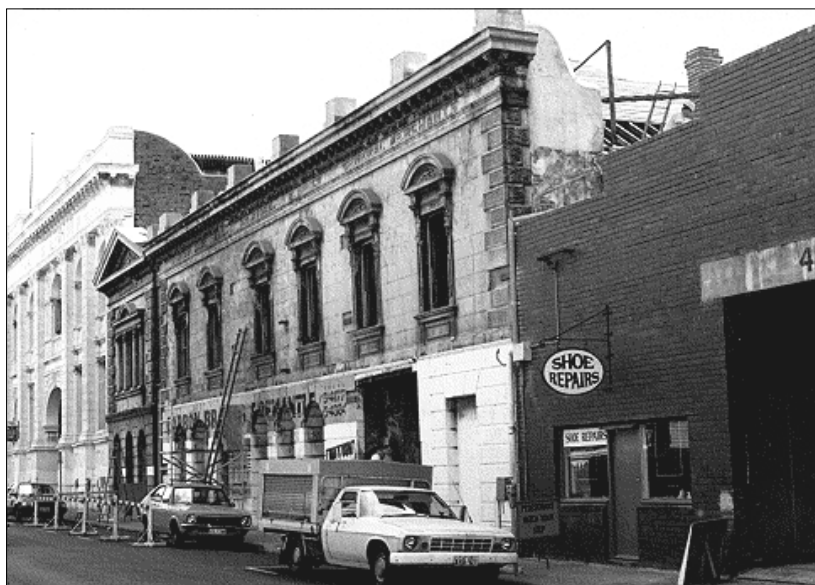
Figure 1: The Moores Building facade in 1986

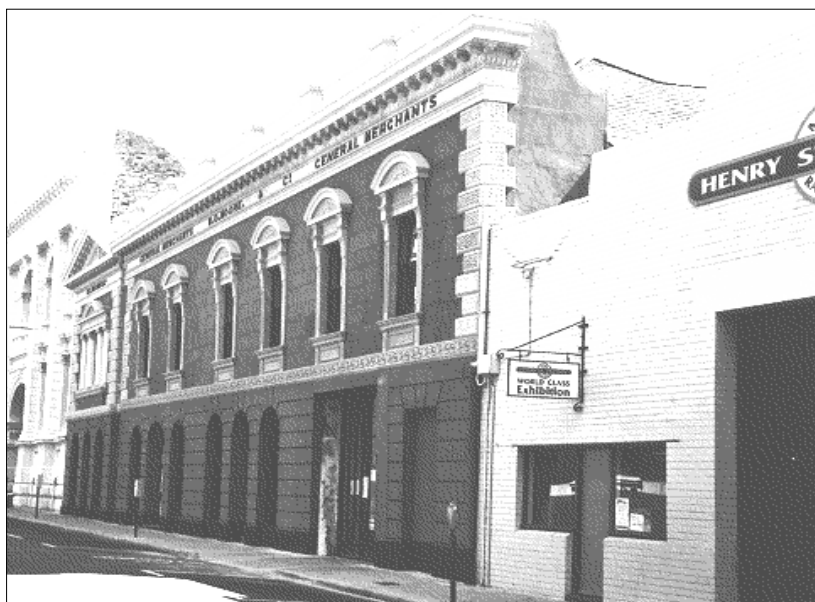
Figure 2: The restored Moores Building facade in 1994

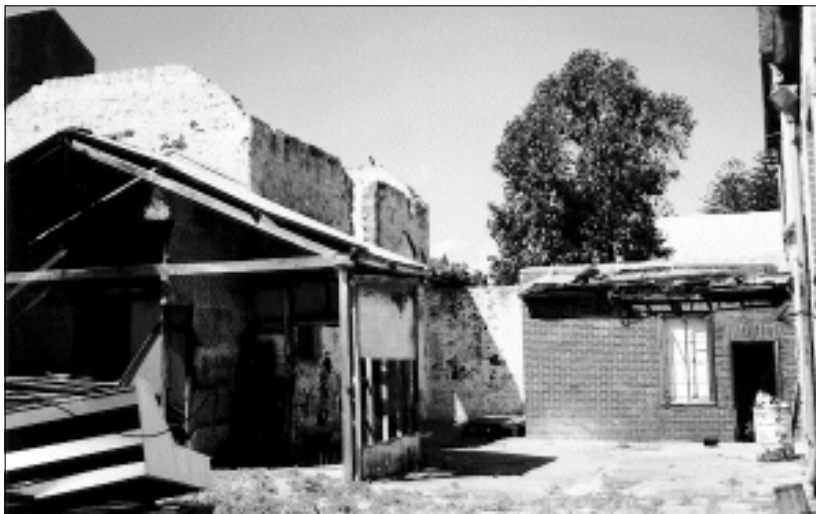
Figure 3: The former derelict rear Warehouse and Workshop

Today the building houses the residence and a commercial space, the Artists Foundation of Western Australia, and, at the rear of the site, workshops for community artists (figs 3 & 4).

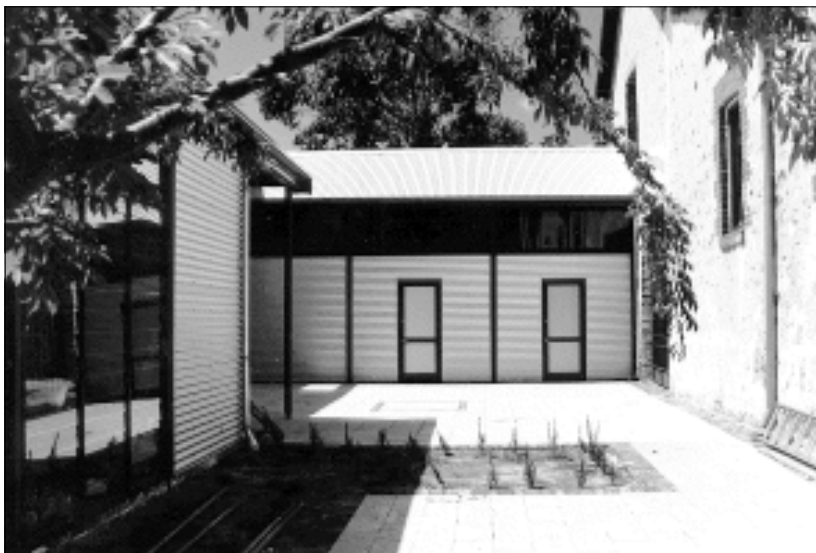
Figure 4: Clearly new buildings within the former building envelopes used as a community arts facility

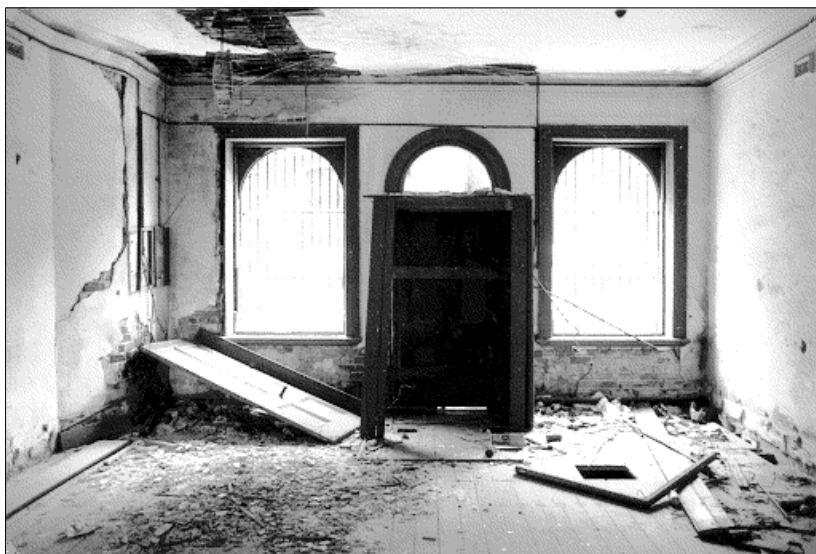
Figure 5: Debris in the front room of the former Residence in 1986

1. Site preparation - years of accumulated debris had to be removed, old stockpiles, rubbish, weeds, and rotting timbers which were affected by termites. The site was then made safe, and examples of building materials such as bricks, mortar, joinery and shingles were put to one side (fig 5).

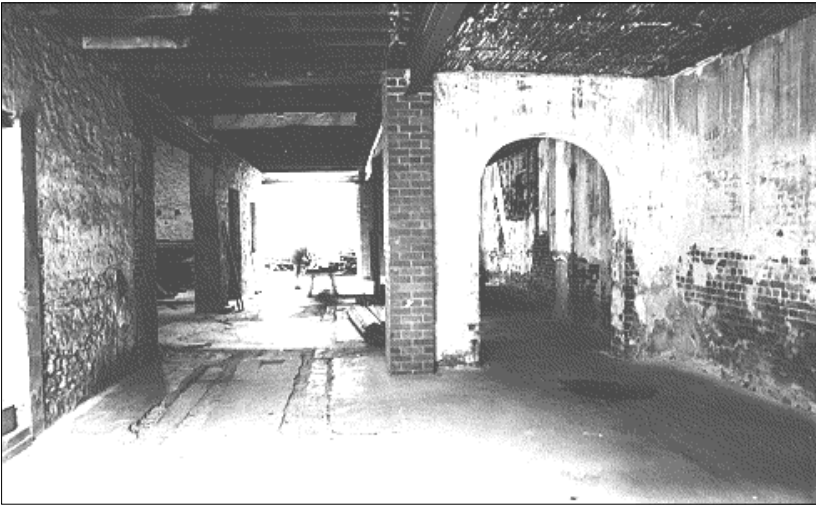
Figure 8: The Cartway prior to restoration

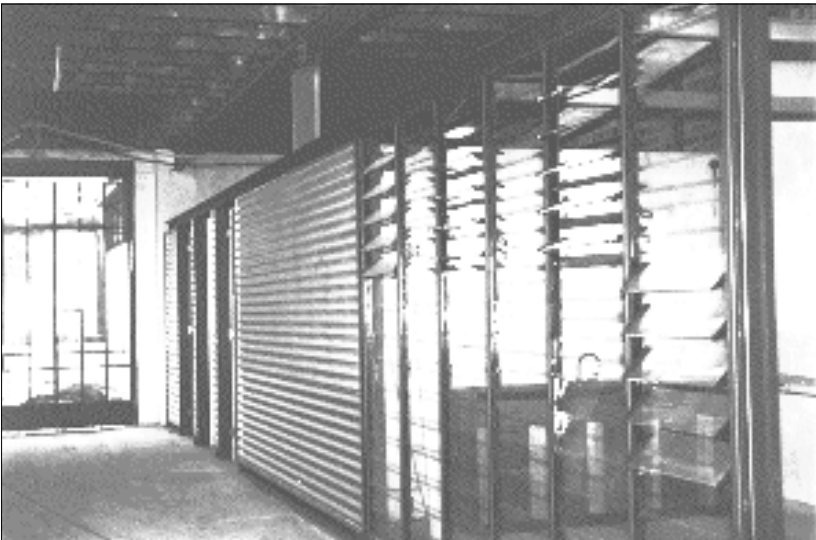
Figure 9: A new wall for the modern facilities constructed on the same plan as a former office wall in the Cartway.

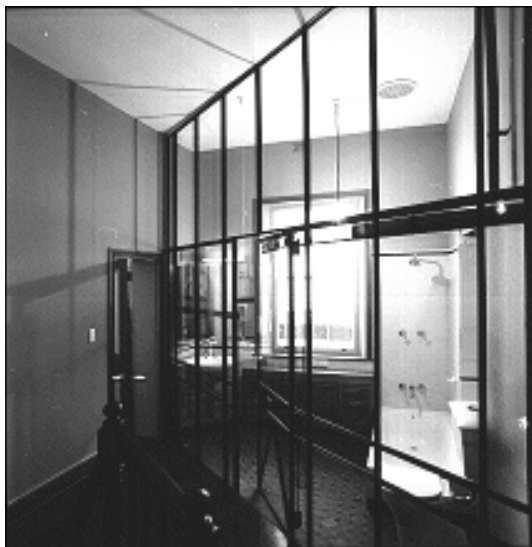
Figure 11: New bathroom facilities which allow the original space and character of the room to be appreciated

Functional requirements created many more opportunities for innovative design work. Another example was the adaptation of the former residence to modern standards including satisfying requirements for internal bathrooms and toilets. Originally these were housed in out-buildings. This requirement produced a real challenge because dividing any space by the small cubicles needed for these facilities could obscure or obstruct the original walls, decorative details or spaces. The solution was to create a glass wall in a steel frame with narrow slatted venetian blinds for privacy (figs 10 & 11). Thus the original space and character of that part of the building can still be appreciated, while creating a bold but sympathetic juxtaposition between modern fixtures and fittings and the character of the original hallway.

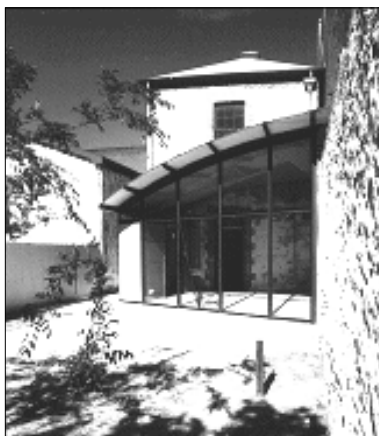
Figure 13: The addition of a modern and sympathetic conservatory provides required living space

Another decision involved the addition to the townhouse of a conservatory so that extra living space could flow on from the kitchen. As this was a completely new structure it had to be sympathetic to the main building without mimicking its colonial style. The resulting design is totally modern yet it succeeds in contributing to the character of the whole space. Even though the architect took the old building as a generator of ideas he came up with a creative modern solution (figs 12 & 13).

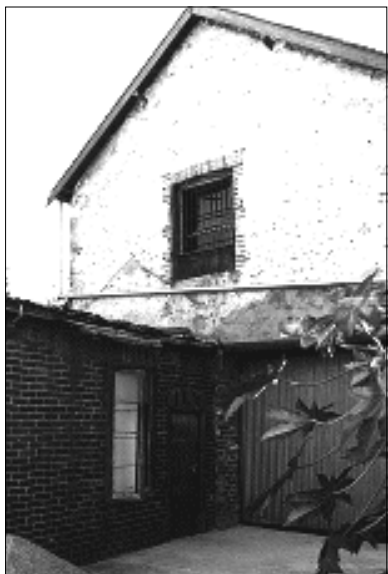
Figure 14: The flashing line of the former Stable roof was evident on the rear wall of the warehouse

needs of the client. In the absence of full physical evidence, decisions were made based on a thorough knowledge of what existed before. Clearly stated modern design solutions were used when insufficient information was available. This assists in the interpretation of the building's evolution and form, while avoiding confusion between the restored or reconstructed work and any new work. For example, the overall form of the former stables was reconstructed in accordance with the flashing line on the main building which indicated the height of the original building and the pitch of its former roof (figs 14 & 15). But the former stables' facade, for which no evidence could be found concerning its details, was expressed in a modern style and materials to indicate that it is a 1990's addition.

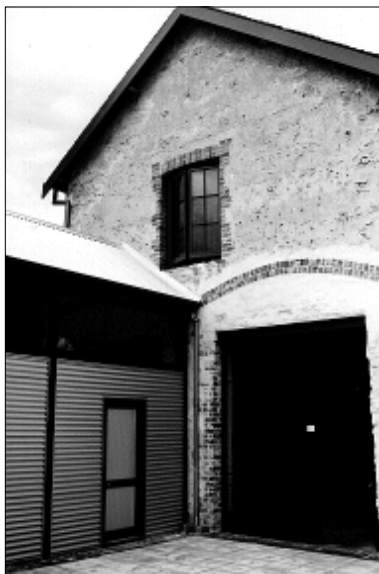
Figure 15: The form of the former Stables is interpreted by the new building. The elevation and details are clearly modern

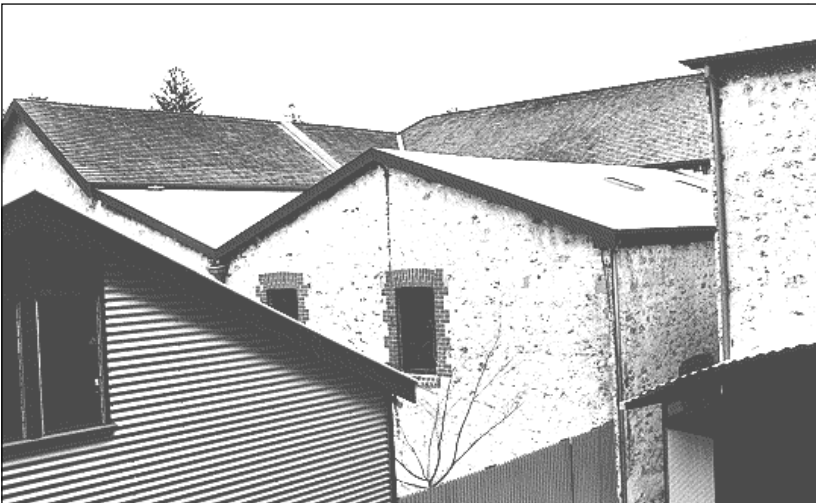
Figure 17: The former Warehouse roof was renovated using materials indicated by the evidence

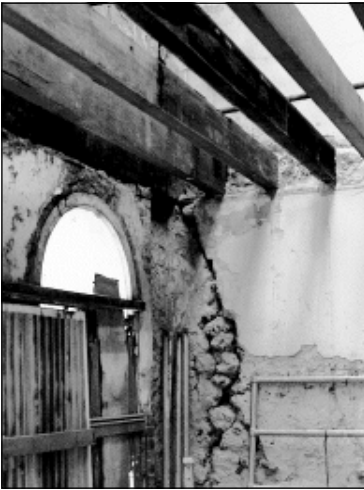
Figure 18: The front facade coming away from the side walls

An interesting aspect of the design process relates to the structural problems which normally present a real challenge in the restoration of old buildings. A knowledge of the building enabled the team to come up with the correct structural solutions to stop the deterioration of the building without compromising its cultural significance or the nature of its internal spaces. Thus the former shingled roof was reconstructed over the early buildings and the corrugated iron over the remaining structures as indicated by the evidence (figs 16 & 17). An example of a major structural problem was the facade. This was the last major significant addition to the complex and was in danger of becoming detached from the main building and falling into the street (figs 18 & 19). The facade was stabilised by implementing the modern solution of introducing post-tensioned metal ties which fixed the facade to concrete anchors within the cross walls (figs 20 & 21). The anchors would normally have been plastered over to make them invisible but in some justified instances they were

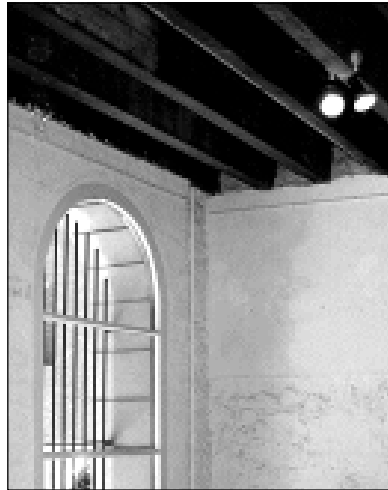
Figure 19: The side walls after repair

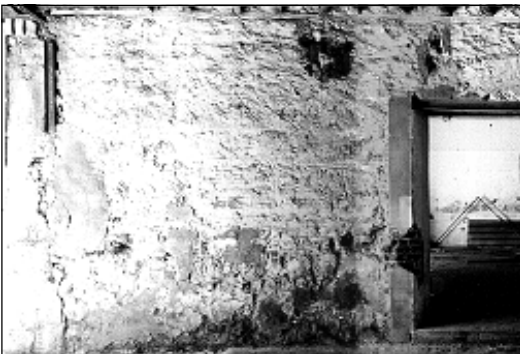
Figure 20: One of the walls which were used to anchor the facade

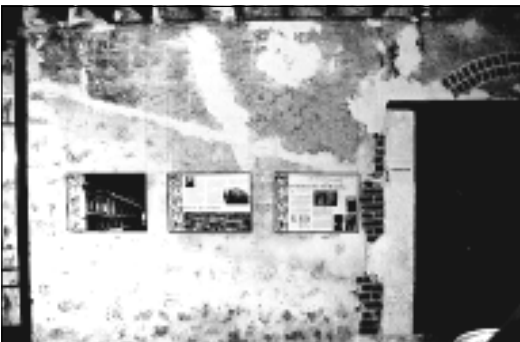
Figure 21: The position of metal ties in the wall and the concrete anchor against the door jam can clearly be seen. Also note the brick quoins and arch to the former doorway

exposed and used to reconstruct former openings in the walls.
